PROJECT: Midnite Mine Remediation REPORT NO: 2021-13

OWNER: Newmont/Dawn Mining OPERATOR: Newmont/Dawn Mining

This weekly report provides a summary of Midnite Mine Site (Site) remediation action (RA) construction activities, quality assurance (CQA), quality control (CQC) and engineering activities for the period June 18 – 24, 2021. The Site activities discussed in this weekly report include, but are not limited to: Site Health, Safety, and Security; Community Liaison, Project Meetings, Regulatory Oversight, Site Visitors; Site Mobilization; RA Activities; Project Documentation; and Site Inspections.

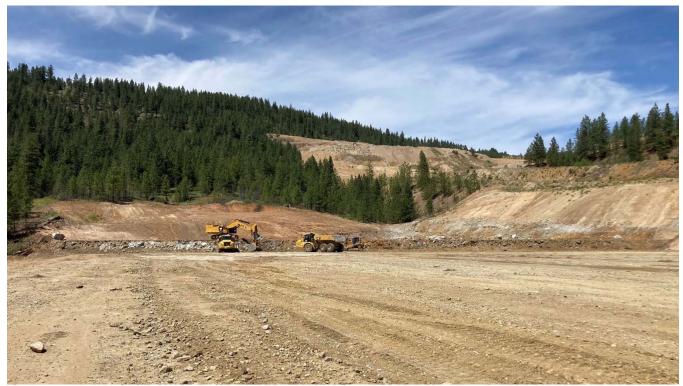
Figure 1 – Excavating low activity/low reactivity material at the SWRP view looking North.

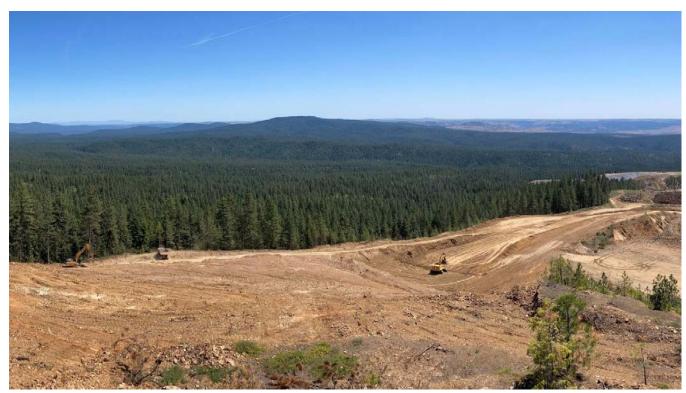
Figure 2 – Excavating low activity/low reactivity material at the Pit 4 Overburden, view looking Southeast.

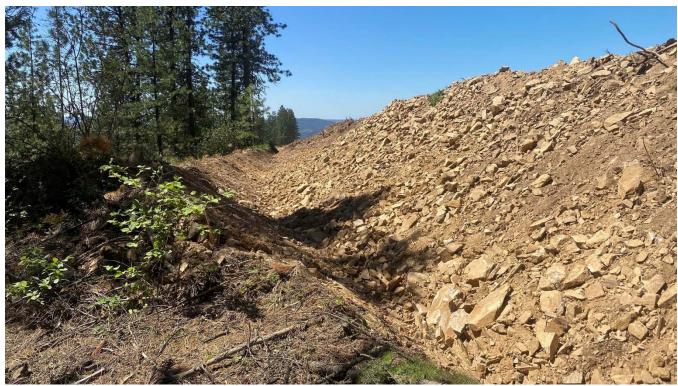
Figure 3 – Drainage channel at the downslope limits of the Pit 4 Overburden Pile removal area.

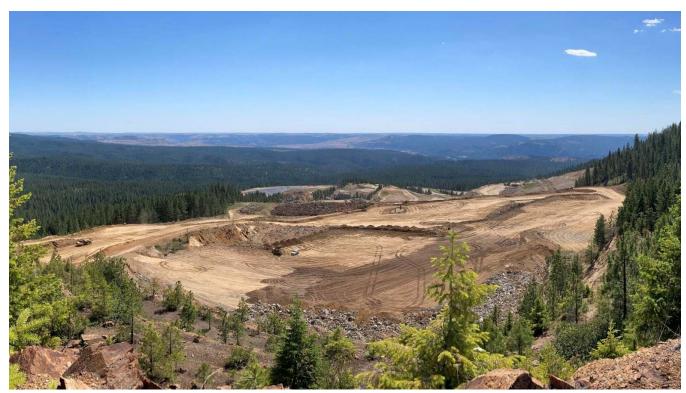
Figure 4 – Placement low activity/low reactivity material in the Pit 4, view looking South.

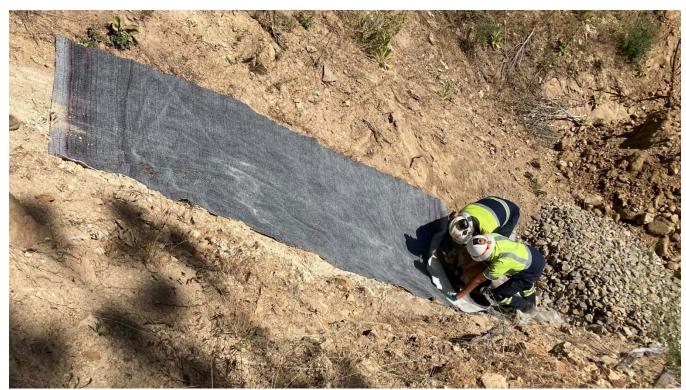
Figure 5 – Installing GCL in Infiltration Collector in Pit 4.

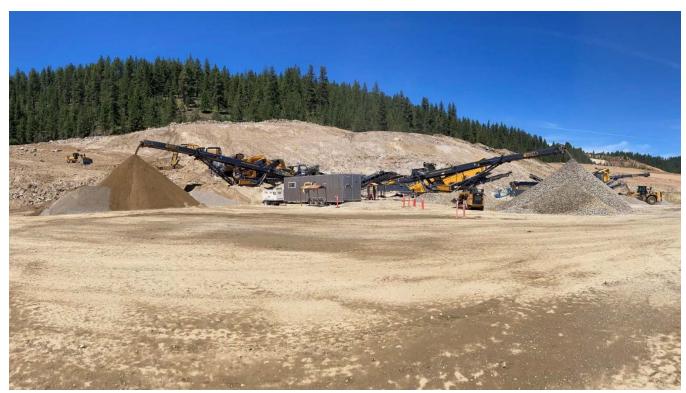
Figure 6 – Crushing and screening operations at the HSWRP.

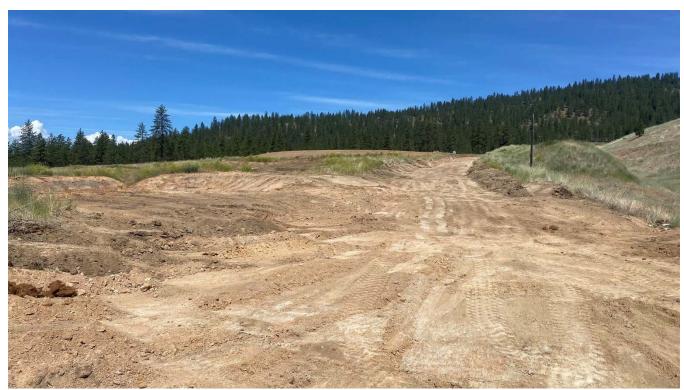
Figure 7 – Progress of visible Mine Waste removal from the CSZ.

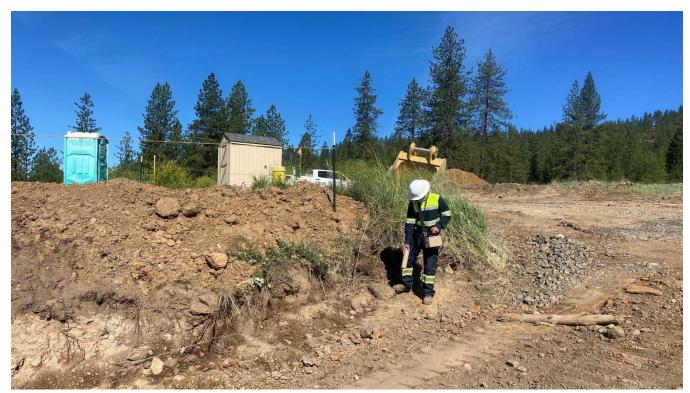
Figure 8 – Conducting a preliminary gamma scan of the surface after removal of visible mine waste at the CSZ.

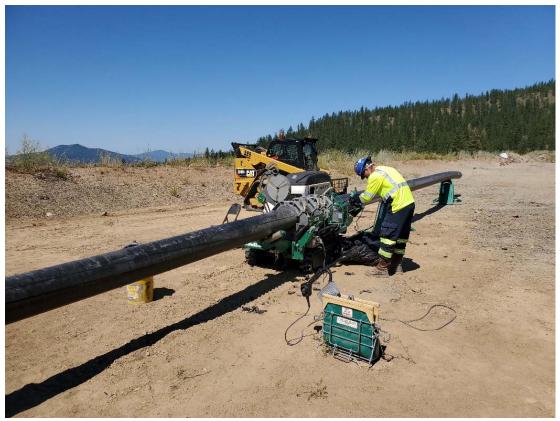
Figure 9 – Utility crew welding 10-inch DR11 HDPE for the Pit 3 dewatering pipeline

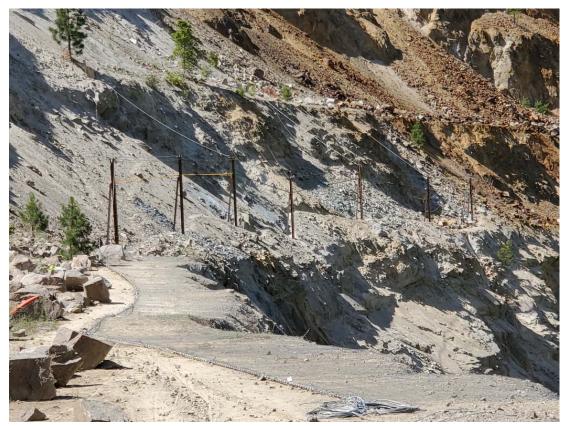
Figure 10 – Pit 3 rockfall protection attenuator posts installed
